Manhole Inspection Summary

Manhole # S03UU1014MH

Inspection ☐ Is Incomplete Rating: **4) Poor**

Location Address: **5817 NARCISSUS AVE**

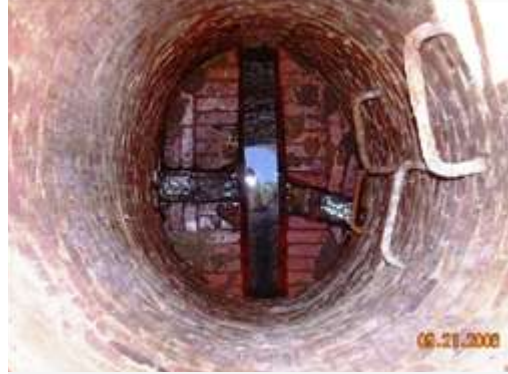
Top View

Corroded steps. Evidence of surcharge - Bench debris.

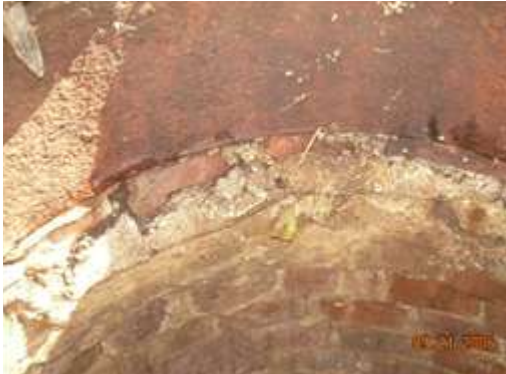
Defect

Frame leaks. Adjustment deterioration and infiltration.

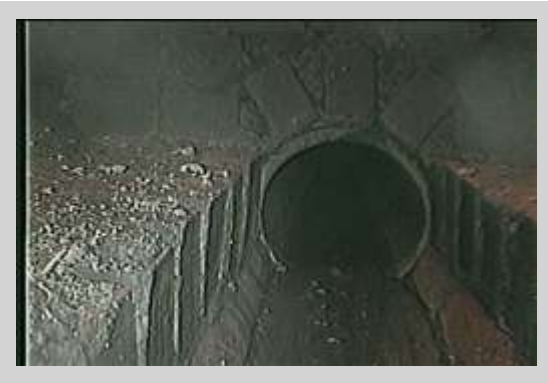
8 in. Circular Gravity Sewer Pipe Out @ 12 O'Clock

Channel deterioration.

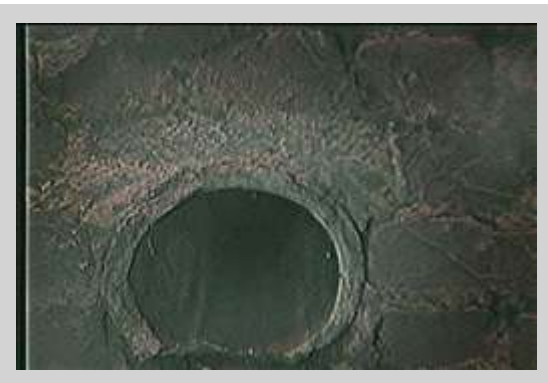
6 in. Circular Gravity Sewer Pipe In @ 4 O'Clock

Barrel root intrusion, deterioration and infiltration.

Infiltration: **Evidence** Pipe Seal Cond: **Cracked**

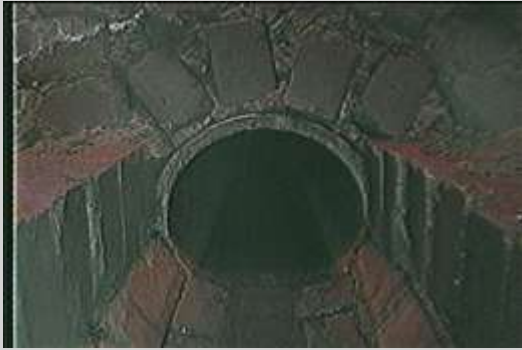
Pipe In @ 6 O'Clock

Barrel deterioration and infiltration. Channel deterioration.
